**"Development of Holistic  
Remediation Alternatives  
for the Catholic 40 and Beaver Creek"**

**Spring 2000 Environmental Capstone Project  
Civil Engineering and Environmental Science  
University of Oklahoma**

**Submitted to  
Governor Frank Keating's  
Tar Creek Superfund Task Force**

**April 28, 2000**

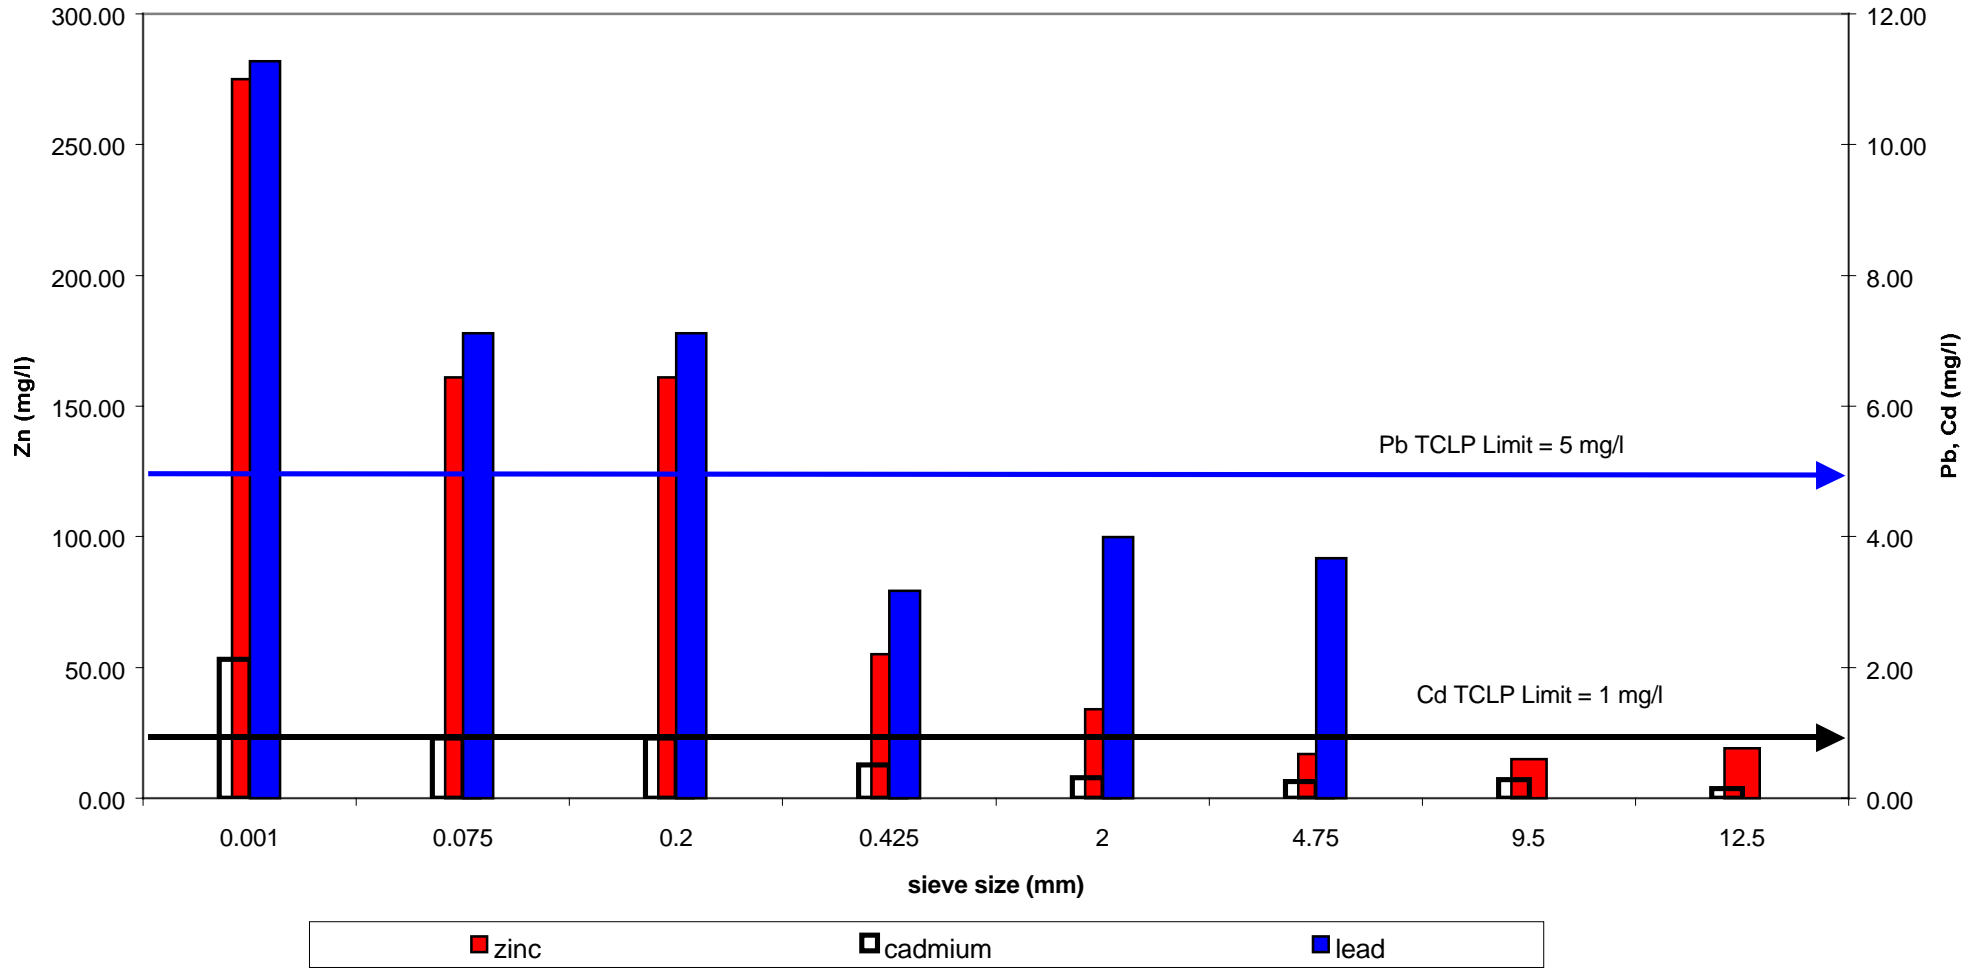
Figure IV-4. TCLP Metals Concentrations in Size Fractions of Composite Sample #1

Figure IV-4 shows the concentrations of TCLP extractable metals for each size fraction in composite chat sample #1. Once again, the highest concentrations of TCLP extractable metals are found in the smaller-sized chat particles. The TCLP hazardous substance criteria for lead and cadmium are also shown on Figure IV-4. In general, chat particle sizes less than 4 mm would be classified as hazardous substances based on leachable metals. Combining the TCLP levels (Figure IV-4) with the particle size analysis (Figure IV-2) shows that approximately 20% of the total chat material on the Catholic 40 site is hazardous. This material should be separated out and handled properly in order to eliminate further contamination of the area and reduce potential exposure.

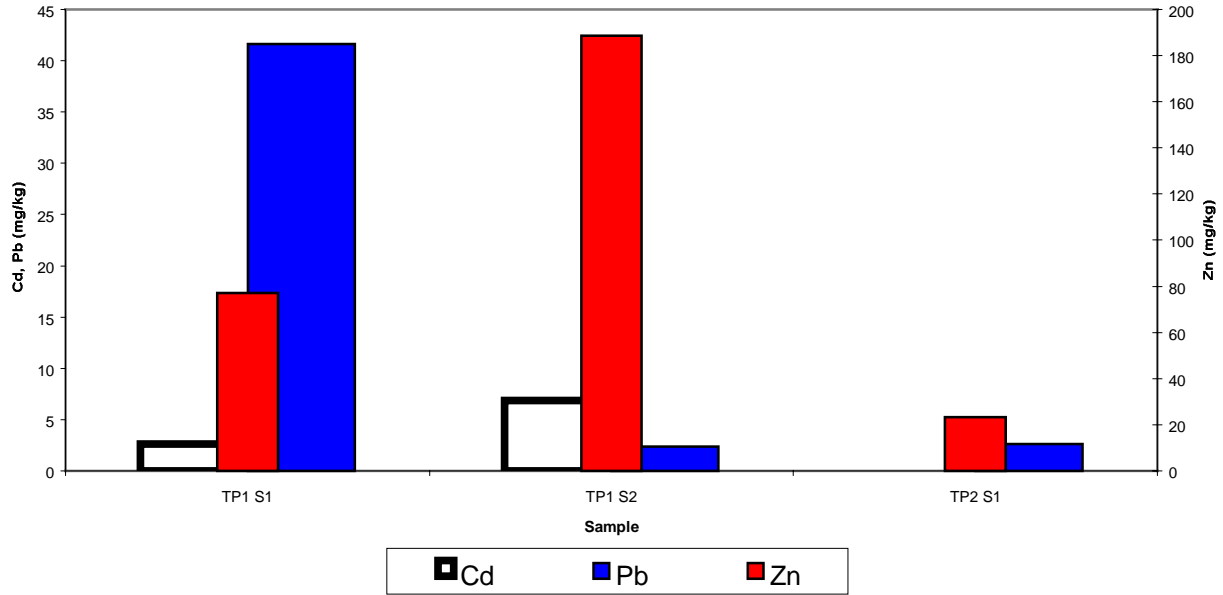
Figure IV-7. TCLP Metals in Tailings Impoundment

The results of TCLP leachability tests conducted on the tailings pond samples are depicted in Figure IV-7. The figure shows higher concentrations of zinc and cadmium in the surface samples. Zinc concentrations are lower in the tailings pond than in the chat. This is probably due to the fact that historical processing operations targeted zinc for removal from the raw ore. Cadmium concentrations in the tailings pond samples are higher than in the chat and exceed the TCLP criterion; thus, the material in the tailings pond should be considered hazardous. The tailings pond materials should be excavated and properly disposed to reduce potential exposure to cadmium.

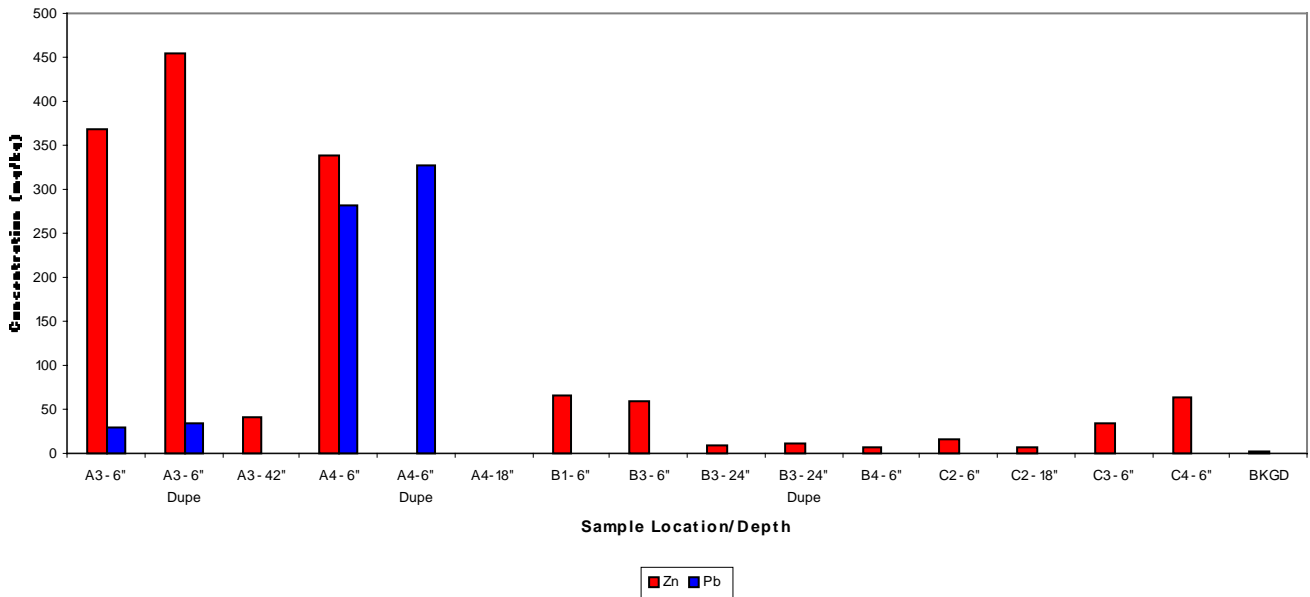
Figure IV-8. Zinc and Lead Concentrations in Soil Samples

There are two important trends associated with the data in Figure IV-8. First, it appears that the metals leached from the chat reside mainly in the upper reaches of the underlying soil (compare Zn for location B3). This seems to indicate that these metals are not highly mobile through the soil system. Of more importance is the obvious elevated concentrations found along the “A” sampling transect, which is located in the flatter land area closest to Beaver Creek (see Figure IV-1). These data indicate that runoff from precipitation has transported the leachable

metals and/or metals-laden chat particles downhill toward Beaver Creek. The decreased slope of the land surface near Beaver Creek reduces the velocity of surface runoff, thus leading to ponding and/or infiltration. The net effect is an accumulation of leachable metals in the soils near Beaver Creek.

Soil samples were retrieved from two depth intervals (where possible) at each sample location shown on Figure IV-1. In addition, a background soil sample was taken from a location across Beaver Creek that did not have any visible accumulation of chat. Figure IV-8 depicts the concentration of leachable zinc and lead in each of the soil samples. It is readily apparent that metals have been leached out of the overlying chat materials and migrated down into the surface soils on the Catholic 40 site. In fact, some of the zinc concentrations found in the soils are over 300 times higher than the background concentration.

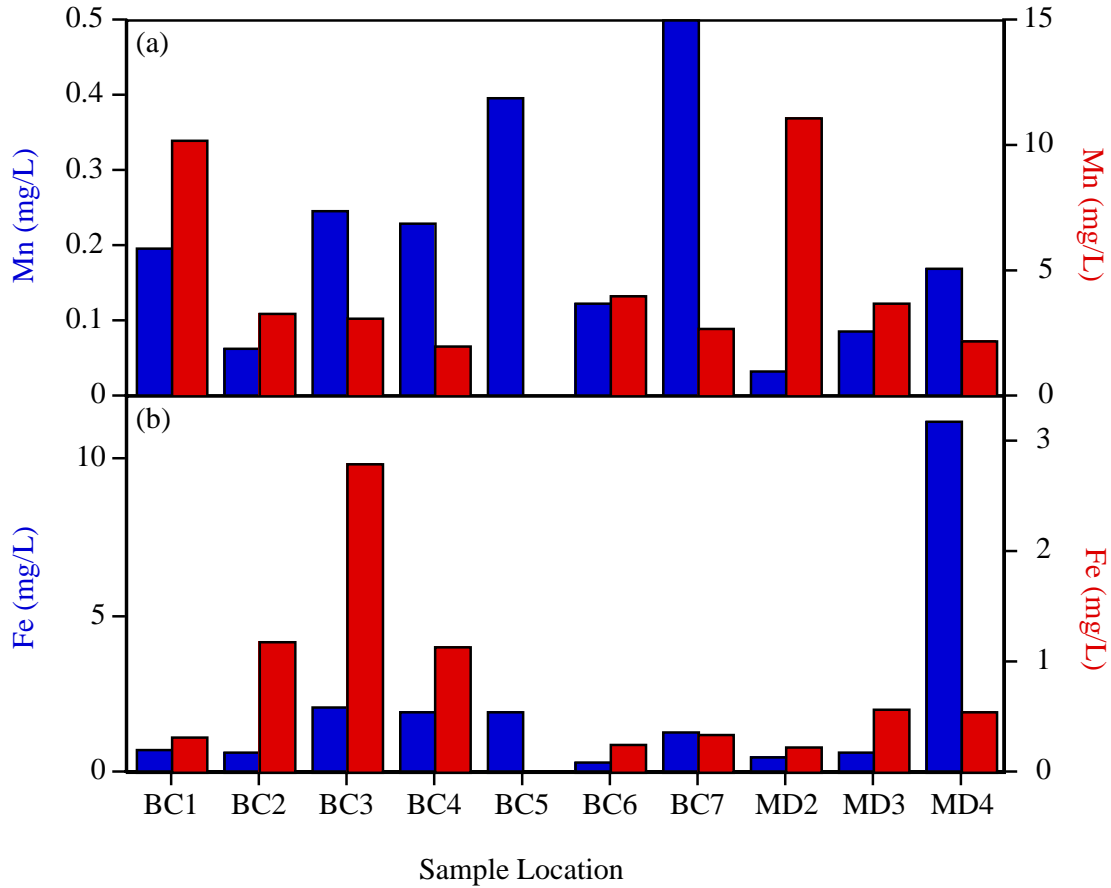
Figure IV-10. Manganese (a) and Iron (b) Concentrations in Beaver Creek. BC is sampling location along Beaver Creek; MD is mine discharge sampling location; ■ is dissolved metal concentration; and ■ is sediment TCLP metal concentration.

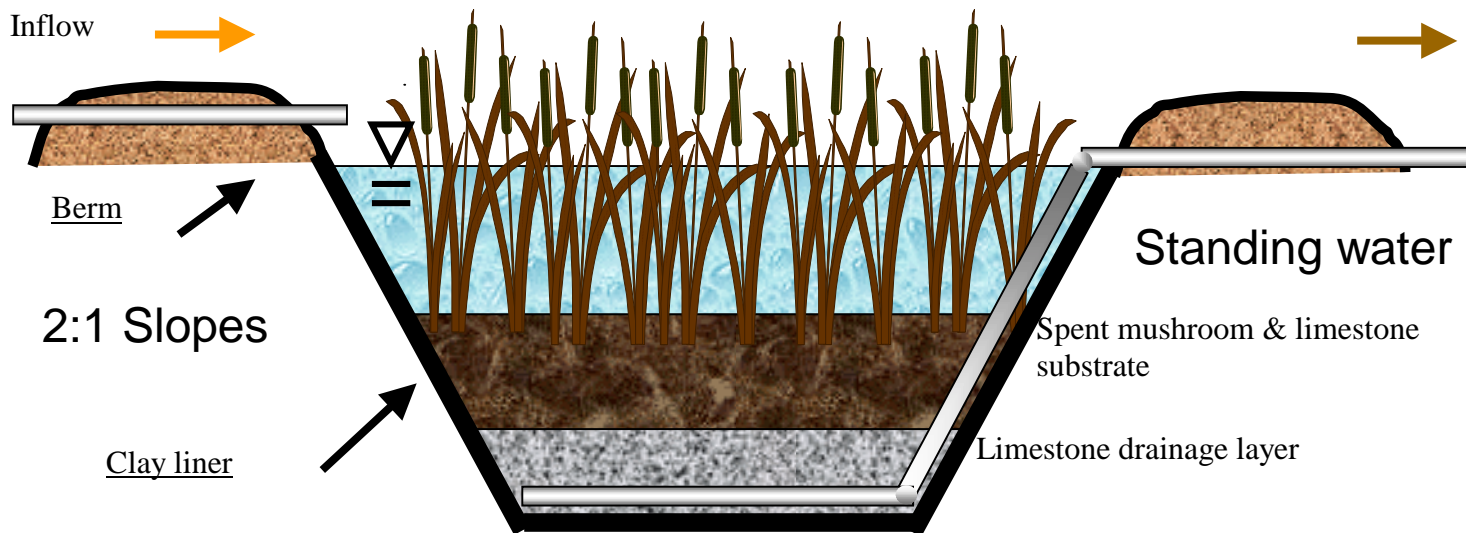
Figure V-3. Vertical Flow Wetland

This cell will be constructed of three layers of media (Figure V-3). The surface layer will consist of 1-1.5 meters of standing water, designed to provide for sufficient hydraulic head to drive the water through to the bottom of the vertical-flow system. Layer two is designed to encourage metal sequestration by means of metal sulfide formation via bacterial sulfate reduction, organic complexation and carbonate formation. Spent mushroom substrate (SMS) will be used as

the organic substrate and will be mixed with limestone (LS) as a means to encourage percolation through the system. SMS is the most common substrate used in mine drainage treatment wetlands in Appalachian coal fields and has been used successfully at a coal mine drainage treatment wetland in Southeastern, OK (Nairn et al., 2000). The ratio of SMS to LS will be 2:1 by volume. SMS can be obtained locally from J&M Farms in Miami, OK and limestone can be obtained from nearby quarries.

Layer three serves as a drainage layer consisting of limestone to act as a permeable layer to transmit the water through underdrain pipes to the Cell 3. Berms will be designed in the same manner as Cell 1 with slopes of 2:1.

Cell 2 is designed as a vertical flow wetland to remove Pb, Cd, and Zn. The size of the wetland is based on Pb, Cd, and Zn removal rates of 0.2, 0.7, and  $1 \text{ gm}^{-2}\text{day}^{-1}$ , respectively. The mass loading from the discharge is divided by the removal rate to give an area (Table V-4). In a vertical flow system, the removal rate of Zn is slow compared to Pb and Cd. In order to optimize removal of all three metals, the size of the system was based on Zn removal rates. The required area for this cell is  $412 \text{ m}^2$  (0.1 acre).
